TEST & EVALUATION REPORT
Screening Evaluation of Shingle Rejuvenator

August 15, 2018

Project No.: BBSS 01-02-01

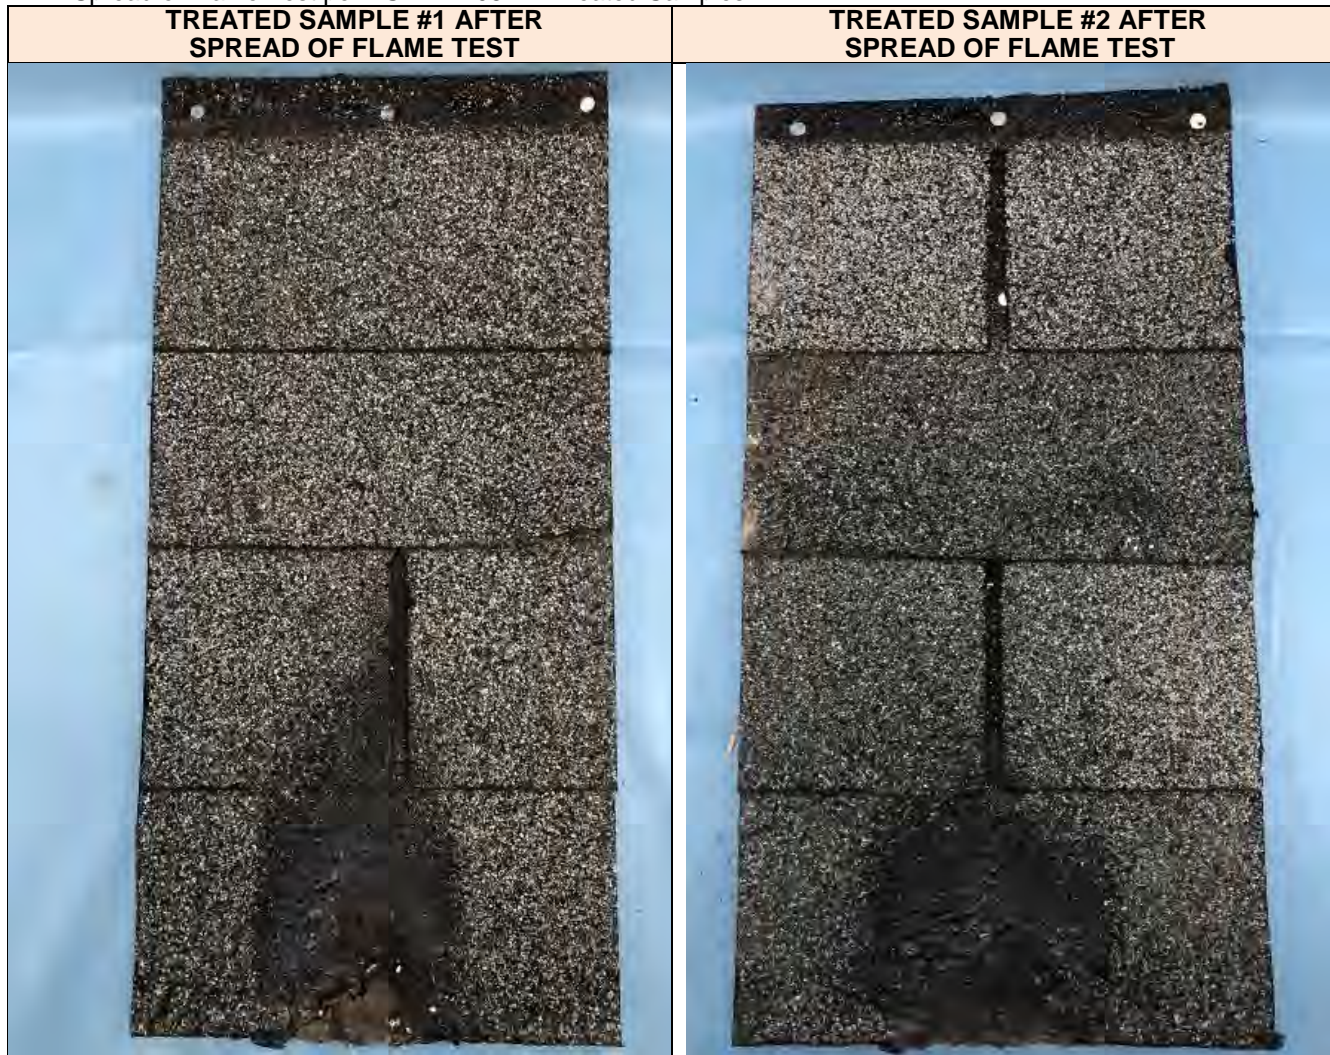
A1. Spread of Flame Test per ASTM E108M – Treated Samples

Spread of flame covered less surface area (a distinct benefit). This is worthy of further investigation.

1. Flexibility_{23°C} was improved (Failure to pass).
2. Granular Adhesion was improved significantly from a granular loss of 1.11 g to a loss after treatment of 0.15 g, an 86% improvement.
3. Hail Impact was slightly improved after treatment. The improvement, 6.6%, was minimized by the type of shingle evaluated – organic felt based. The data suggests Hail Impact would have a greater improvement on FG mat-based shingles.
4. Fire Resistance 'UL Speed of Flame:' The treated shingles exhibited a flame spread of 86 in² vs. the untreated shingles exhibiting a 144 in² spread. This was unexpected.

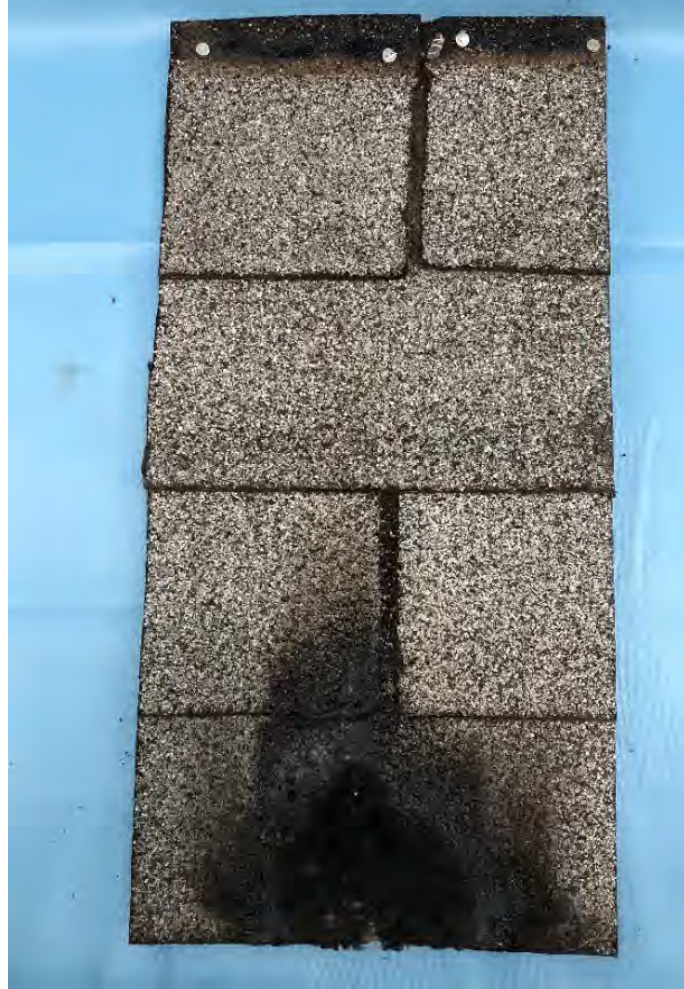
A2. Spread of Flame Test per ASTM E108M – Untreated Samples

- UNTREATED SAMPLE #3 AFTER SPREAD OF FLAME TEST	-

The control exhibited significantly more spread and damage than the treated shingles.

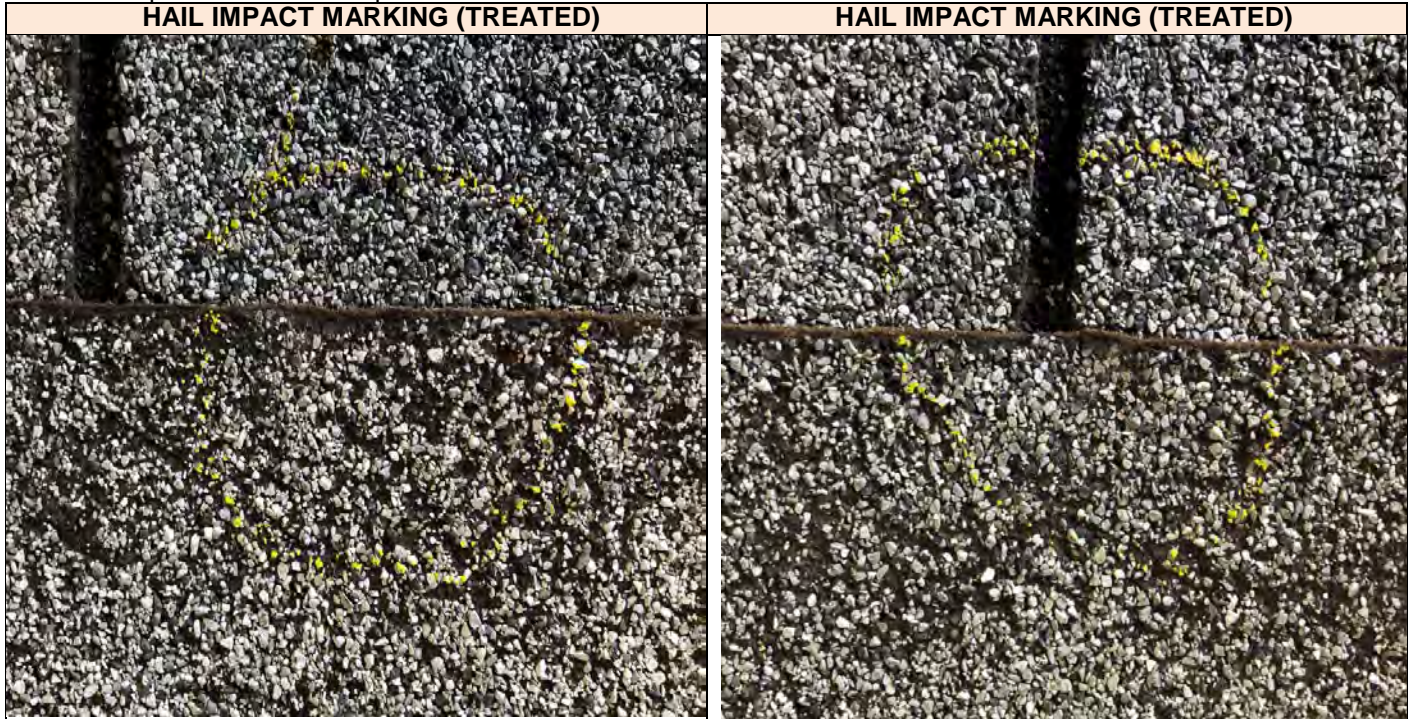
A5. Hail Impact Steel Ball Test per UL 2218 on Treated Material

Because the test shingles were organic felt based, the criteria for Hail Impact Resistance; cracking, and damage to the shingle surface was not observed.

Consequently, we included photos exhibiting the results on the granular surface. The results were mixed primarily due to the severely aged conditions of the test shingles. However, the treatment appeared to re-adhere the granules, which reduced the surface damage some.

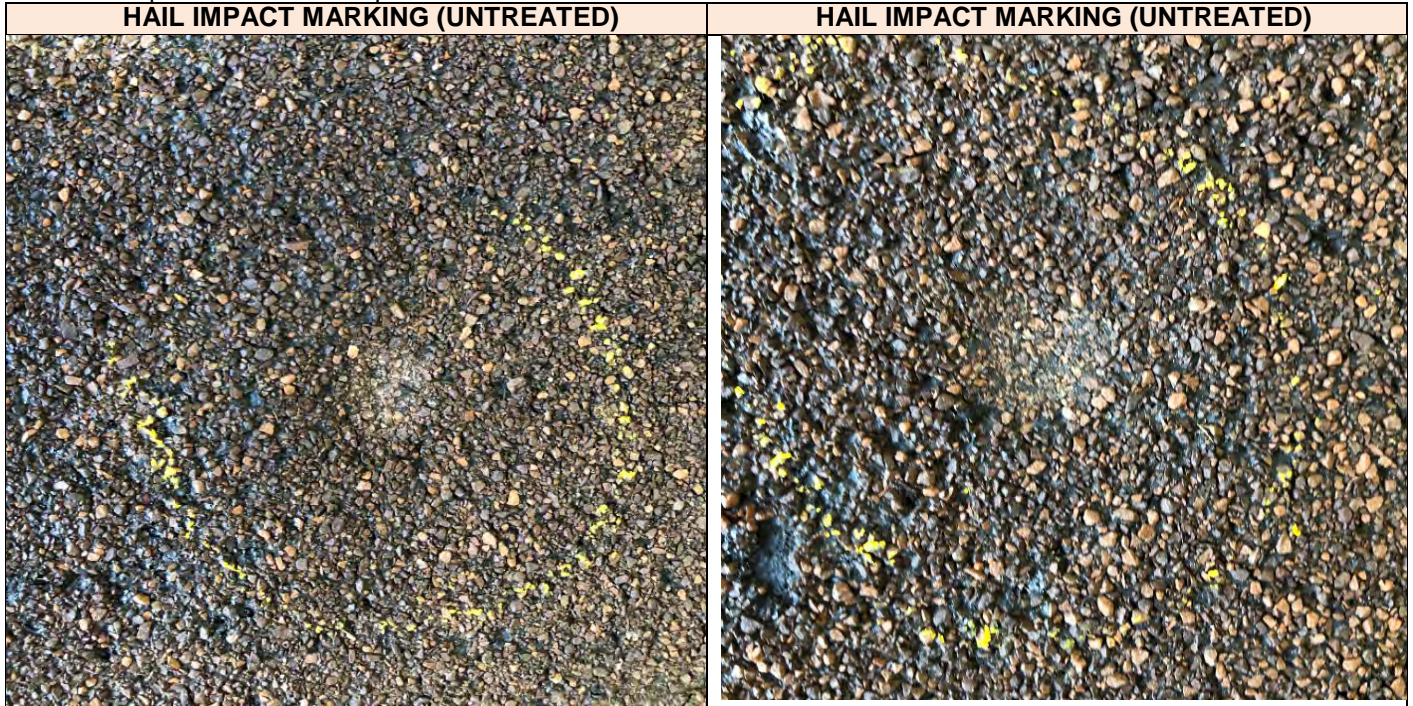
A7. Hail Impact Steel Ball Test per UL 2218 on Untreated Material
